Water Pollution Survey
Community of Lavigne
District of Nipissing

Re: Township of McPherson - Community of Lavigne
Water Pollution Survey.

REPORT
ON A
WATER POLLUTION SURVEY
OF
THE COMMUNITY OF LAVIGNE
DISTRICT OF NIPISSING

DISTRICT ENGINEERS SECTION
SANITARY ENGINEERING BRANCH

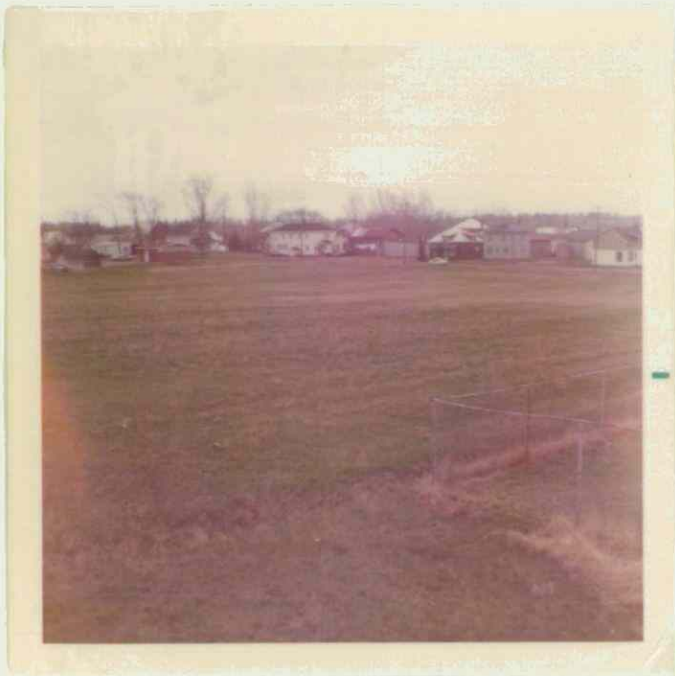
Photo #1

Looking southeast from rock outcropping at Junction of Highway #64 and Caron Road. Note characteristic flatness of clay overburden. Lavigne Hotel and post office are evident in background (white frame building and red brick building respectively).

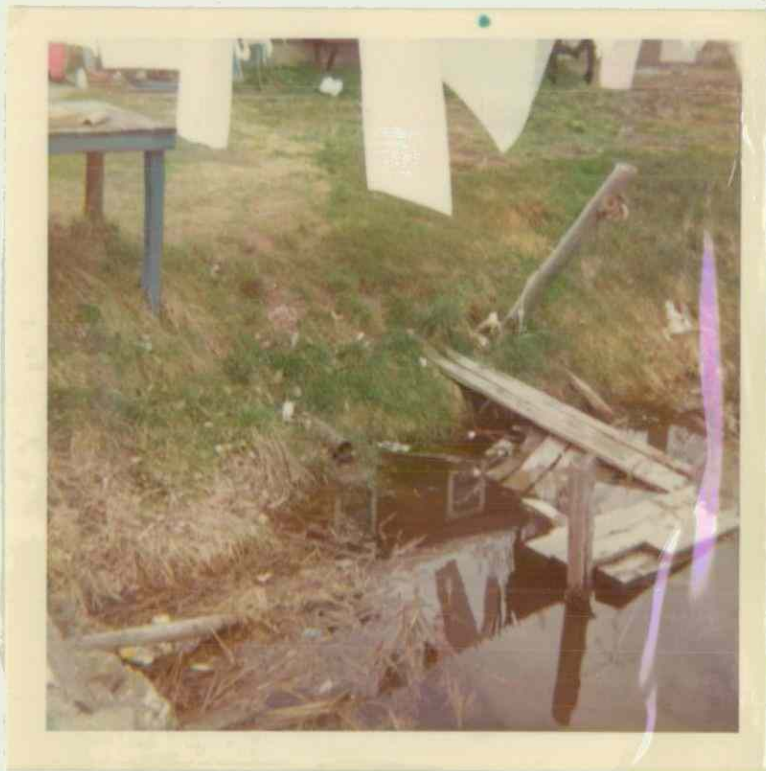
Photo #2

The obvious sources of pollution in the area of Lavigne Creek are septic tank discharge pipes from homes and cabins on the banks of the creek. A four-inch diameter cast iron pipe carries the hotel's septic tank effluent to this creek. This location is displayed in the appended photograph, No. 2. It was evident from viewing several homes along this creek bank that sewage was discharging directly to the water. In the area of Caron Road and the small creek, there are two obvious discharge pipes. It is apparent that septic tank - tile bed systems do not operate successfully with the existing clay overburden. 2

Looking northwest from private bridge over Lavigne Creek. The effluent pipe (4" C.I.) from the hotel is evident in the centre of the photo (sample point #12). Other sewage effluents are hidden immediately to the right of the photo.

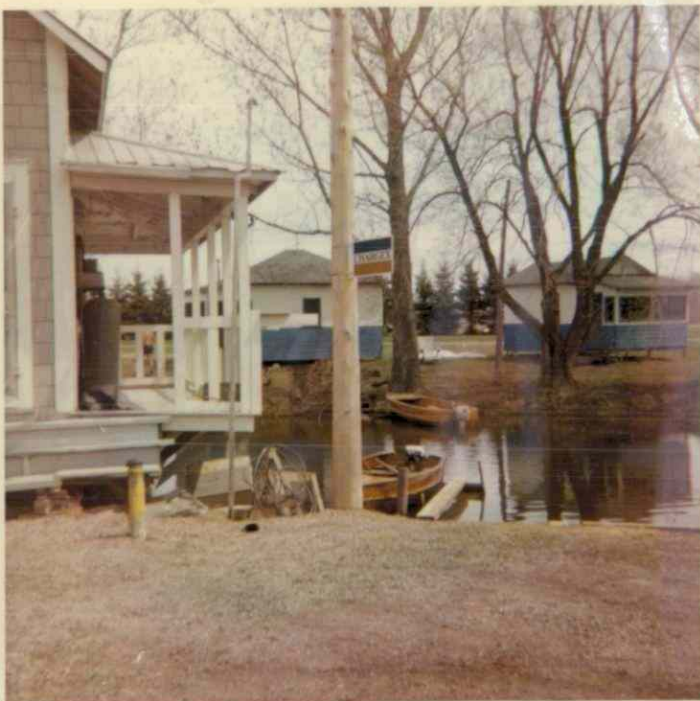
Photo #3

Looking east from Highway #64 across Lavigne Creek. Sewage from the building immediately to the left is openly directed to the creek with no apparent treatment. The left cottage on far bank has just received the repair and reconstruction of the septic tank effluent pipe to the creek. It is evident just below the cottage. This method of disposal is typical.

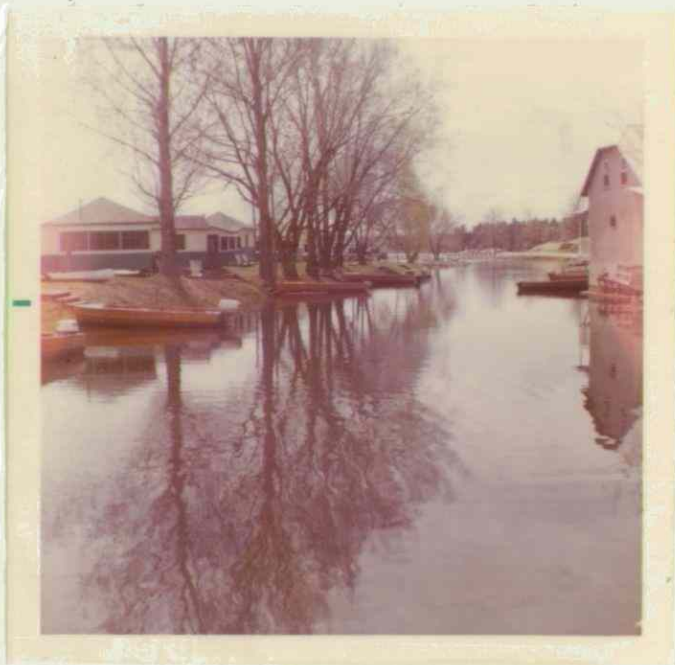
Photo #4

Looking south from private bridge towards Northwest Bay. This picture portrays the recreational activity in the area. None of the residences in this picture have adequate sewage disposal systems. The building on the right discharges sewage directly to the creek (Standard cast iron sewage pipe can be seen at the base of the building).

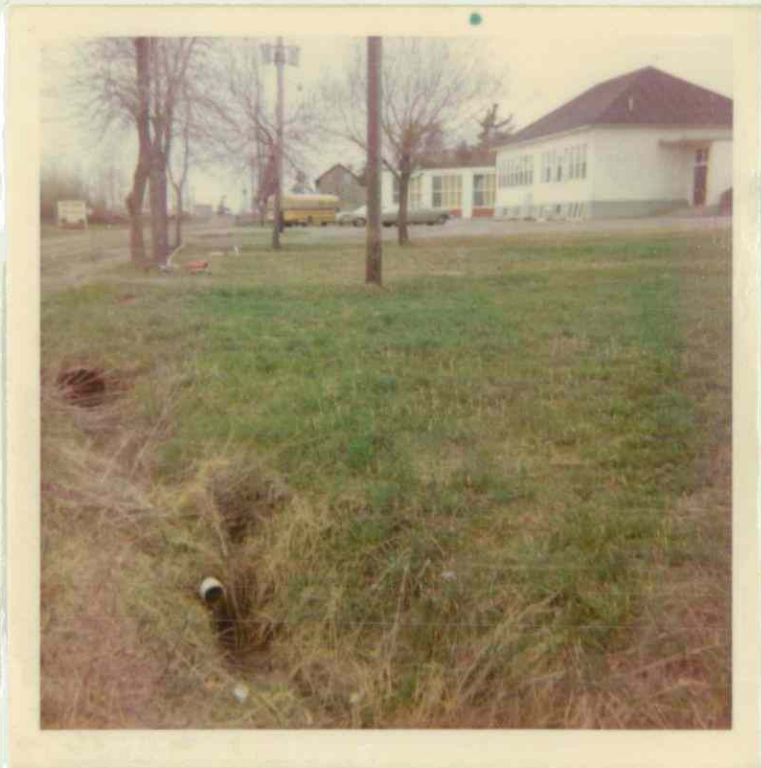
Photo #5

Samples which were collected later on May 16, 1972 indicated faecal coliforms to be similarly present in all cases. Sample 6 contained extremely high faecal coliform counts of 3 million per 100 ml. This sample was collected from the 4-inch diameter A. C. pipe located on the north ditch on Caron Road just south-east of the public school. It is evident that this is the effluent pipe from the existing school's tile bed system. High concentrations of faecal coliforms were also present at Sample Point 4, 8 and 10. These examination results indicate that sewage is present in the ditches on Caron Road and in the creek adjacent to the public school and in all the areas of Lavigne Creek. A sample of Lavigne Creek at the mouth was collected for chemical analyses. The results indicate that the BOD at this location was 30 ppm which far exceeds the generally accepted range for surface waters; the BOD of natural water is usually below 4 ppm. Phosphorus and nitrogen concentrations were found to be high at points 3 and 8. The generally accepted maximum limit for these parameters are 0.02 ppm and 0.5 ppm respectively for natural surface waters. These increased concentrations of nutrients indicate that sewage is gaining access to the watercourse.

Looking northwest from Caron Road at the public school. The 4" diameter asbestos concrete pipe (sample location #6) is evident at the lower left. This is reportedly septic tank effluent. The creek is immediately below the photo.

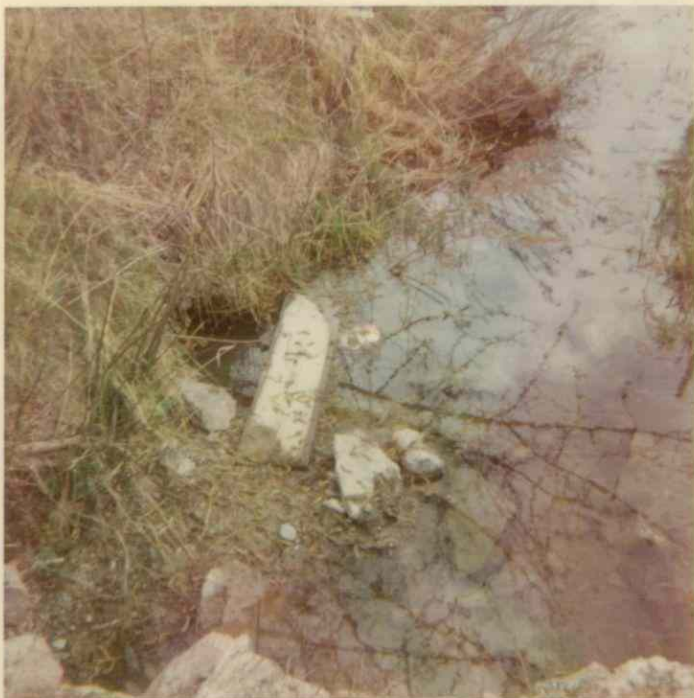
Photo #6

The chemical analyses of the discharge sample collected at the ditch south of Caron Road (7) indicates both a BOD (biochemical oxygen demand) and suspended solids concentration of 60 ppm which far exceeds this Ministry's objectives for surface waters. Analyses results of the effluent sample from the hotel indicate a similar condition. Bacteriological examination

Looking southeast from Caron Road at the Creek. Sewage effluent is evident from centre of photo (sample location #7) and runs south towards Northwest Bay.
